INVESTIGATION OF TANTALUM WET SLUG CAPACITOR FAILURES IN THE APOLLO TELESCOPE MOUNT CHARGER BATTERY REGULATOR MODULES

INTERNATIONAL BUSINESS MACHINES CORP.,
HUNTSVILLE, ALA. ELECTRONICS SYSTEMS
CENTER

31 JAN 1973

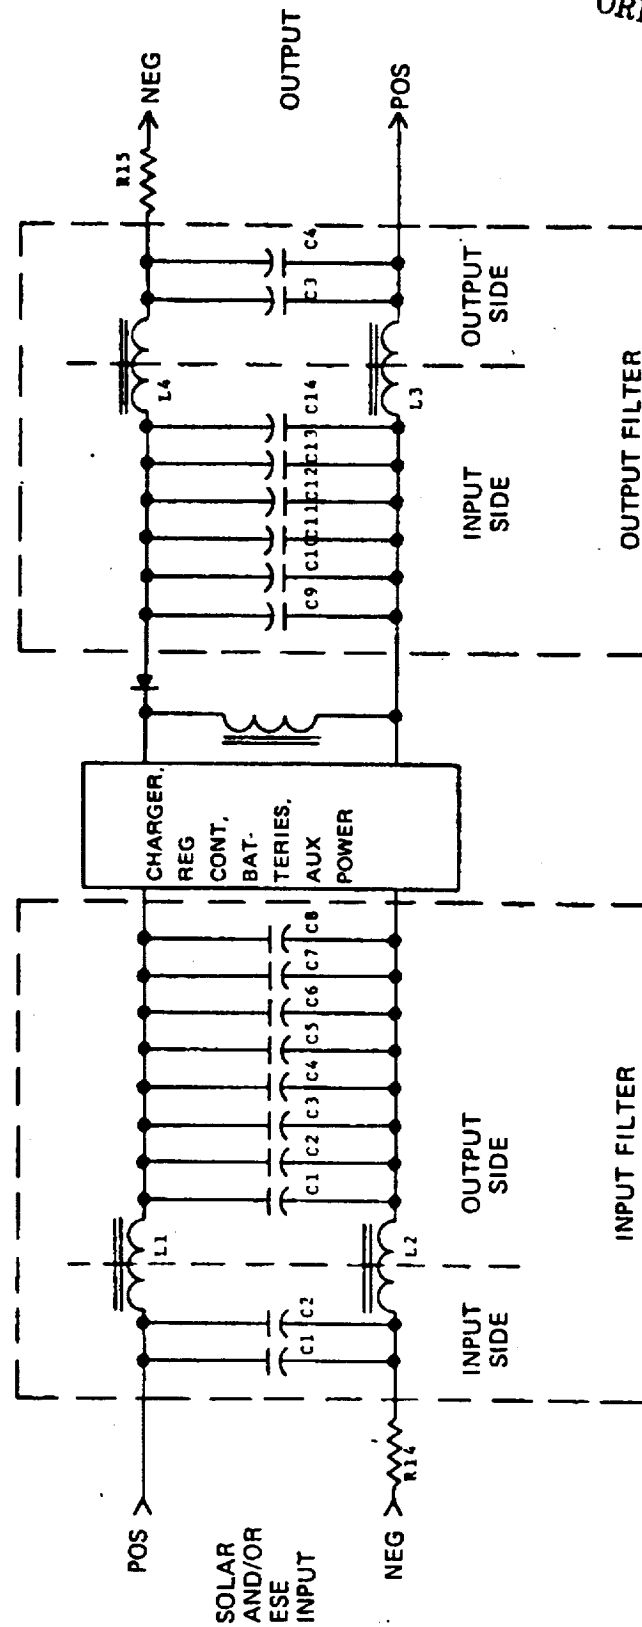
Figure 1.1-1. Schematic of CBRM Input and Output Filters.

The Apollo Telescope Mount (ATM) contains eighteen Charger Battery Regulator Modules (CBRMs). Each CBRM has an input filter and an output filter containing tantalum wet slug capacitors. (See Figure 1.1-1). During ATM system tests at MSFC, MSC and KSC, seven CBRM's experienced capacitor failures. One failure occurred in the input side of the input filter, and seven in the output side of the input filter. No failures have been experienced in the output filter.

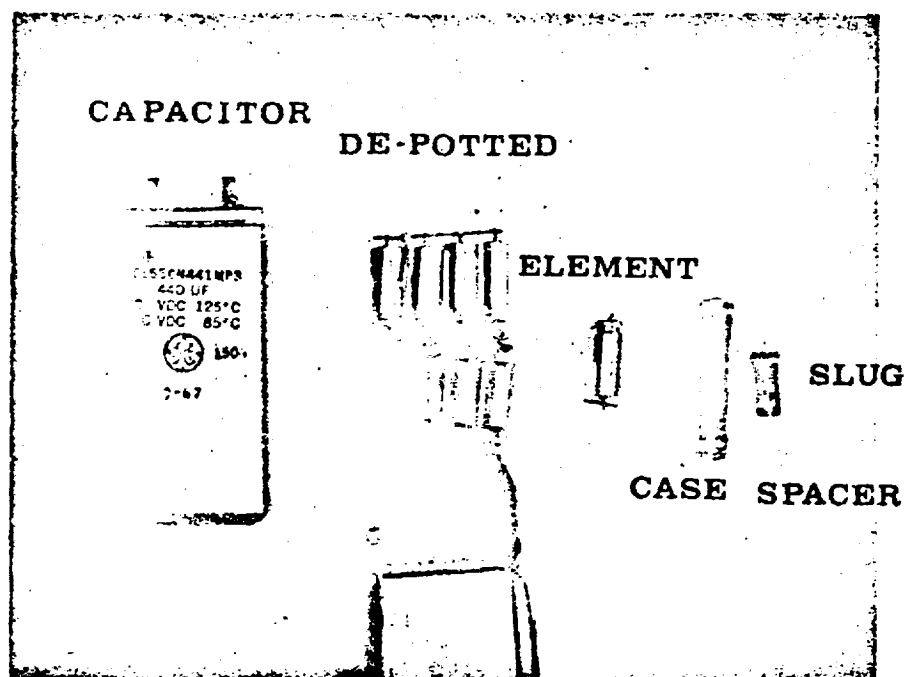
Photo 1.2-1. CBRM capacitor showing internal assembly and element construction.

The capacitors failing in the CBRM were wet tantalum electrolytic devices manufactured by the General Electric Company. Each capacitor is, in reality, an assembly containing sixteen individual capacitor elements potted in a case. (See Photograph 1.2-1).

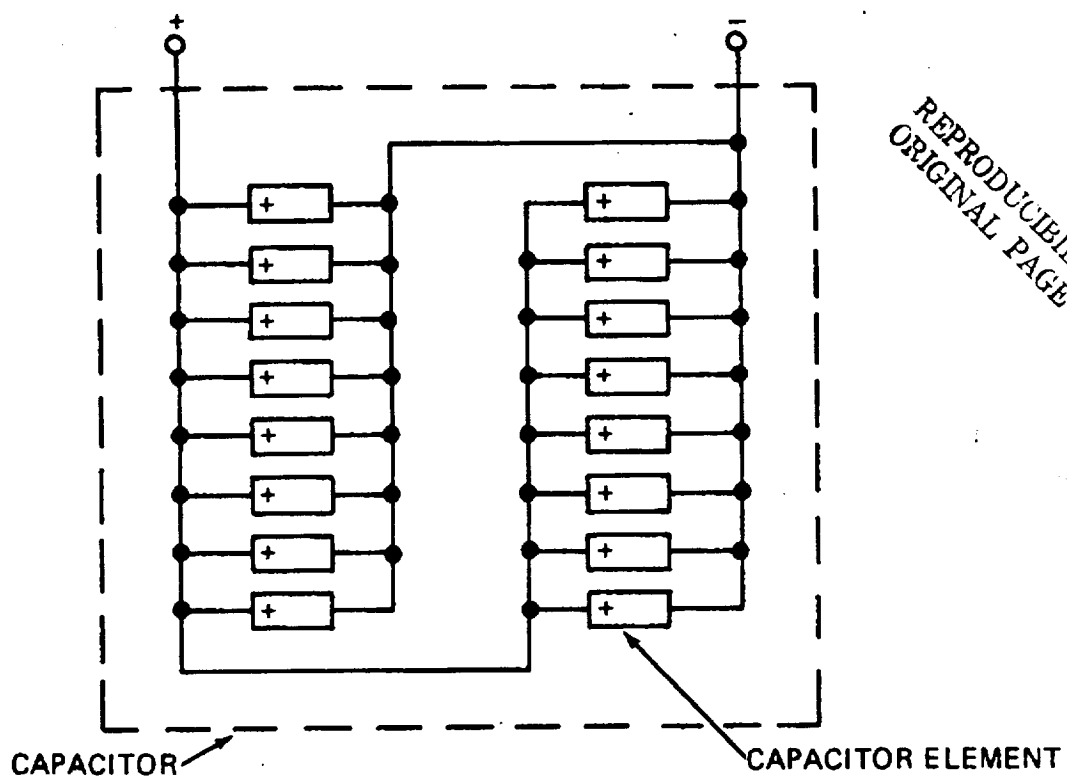
Figure 1.2-1. Electrical Configuration of Capacitor Prior to Mid-1971.

Prior to mid-1971, the assembly contained sixteen capacitors wired in parallel. Each capacitor element is rated at 27 microfarads, 100 volts dc. Capacitor

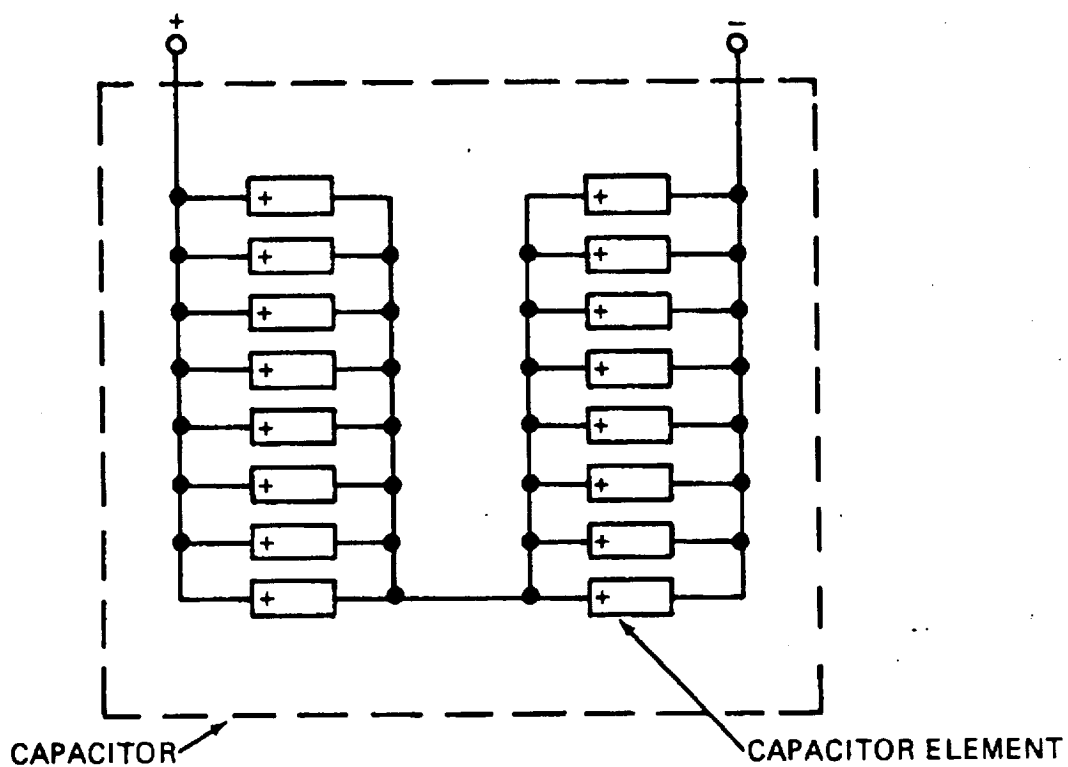
Figure 1.2-2. Electrical Configuration of Capacitor After Mid-1971.

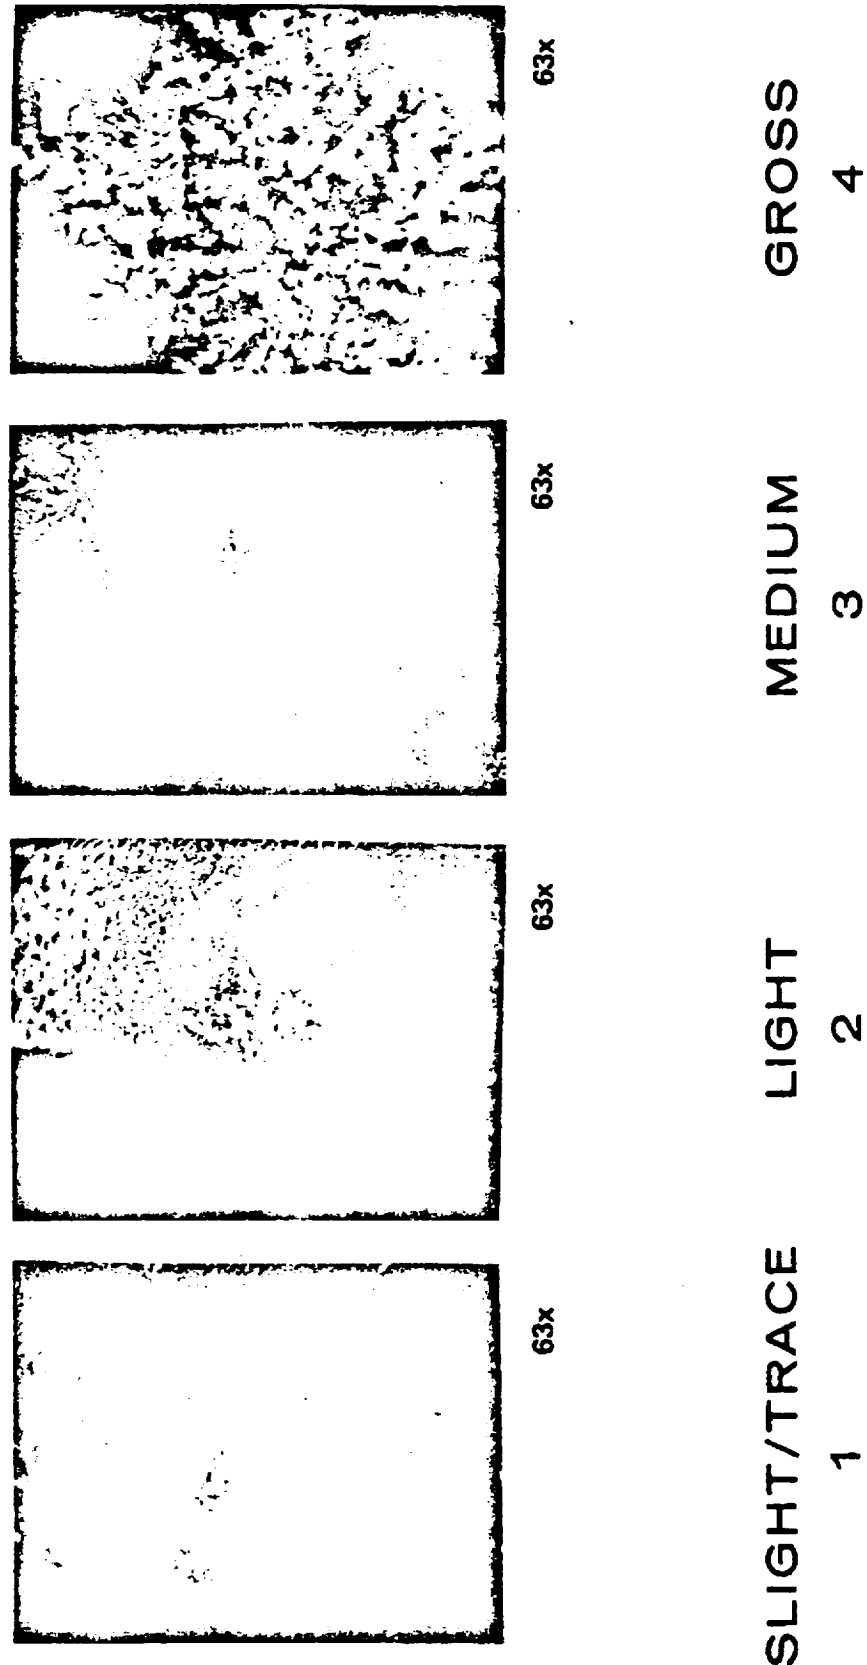
Figure 2.2-1. Capacitor Anode Silver Plating Criteria.

The anode of the capacitor elements is tantalum, and the cathode is silver. The suspected cause of failure was plating of silver from the cathode onto the anode. Figure 2.2-1 shows the criteria established for defining the relative quantity of silver plated on the anode. Capacitors tested and opened were visually characterized for degree of silver plating. It was impossible to correlate failure with quantity of silver. Also, some off-the-shelf capacitors were opened and were found to have slight silver plating. Hence, although failure analysis with regard to quantity of plated silver was inconclusive, the silver plating with subsequent dielectric penetration is the apparent failure mechanism.

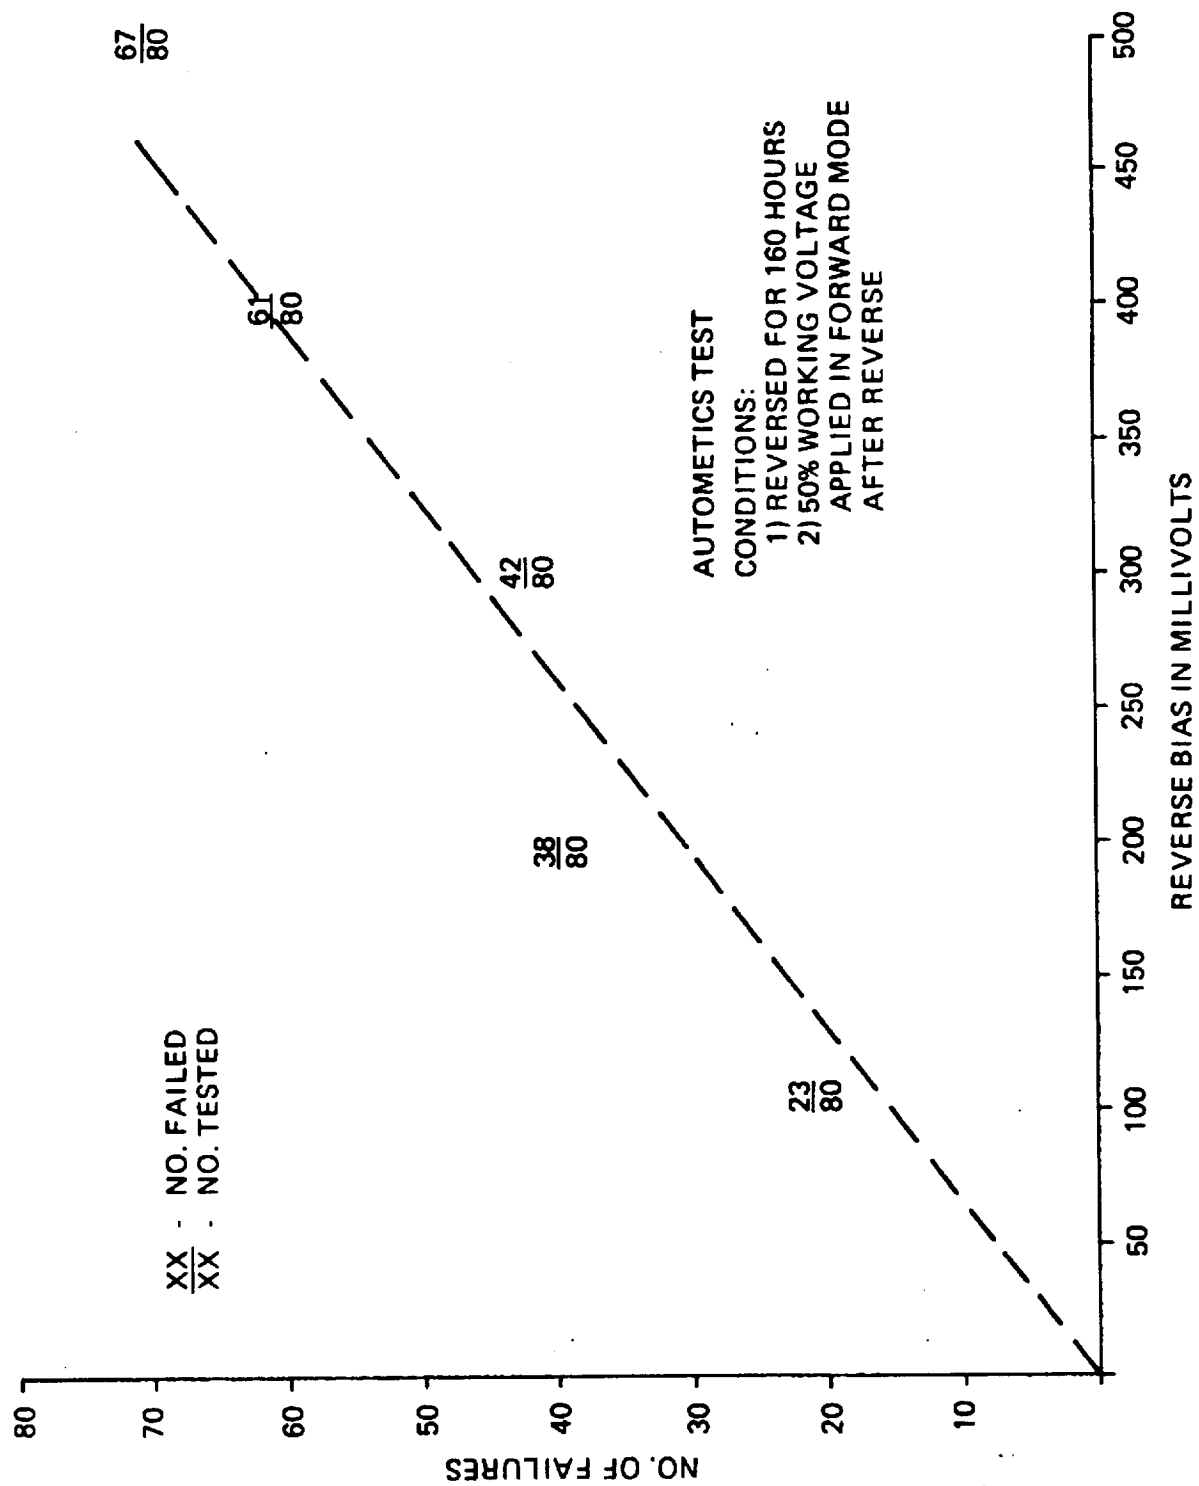
Figure 5.2-1. Autometrics Reverse Bias Test Data.

Figure 5.2-1 presents results of tests performed by North American Rockwell, Autonetics Division. Tantalum wet slug capacitors were subjected to reverse voltages of 100 to 500 millivolts for 160 hours and then 50% of rated forward voltage was applied. As expected, the failure rate increased with increasing reverse voltage. It is concluded that the slope of the plot can be raised or lowered by varying reverse bias application time and/or amplitude of the forward voltage applied after the reverse time period has been completed. It is also suspected that the degree of current

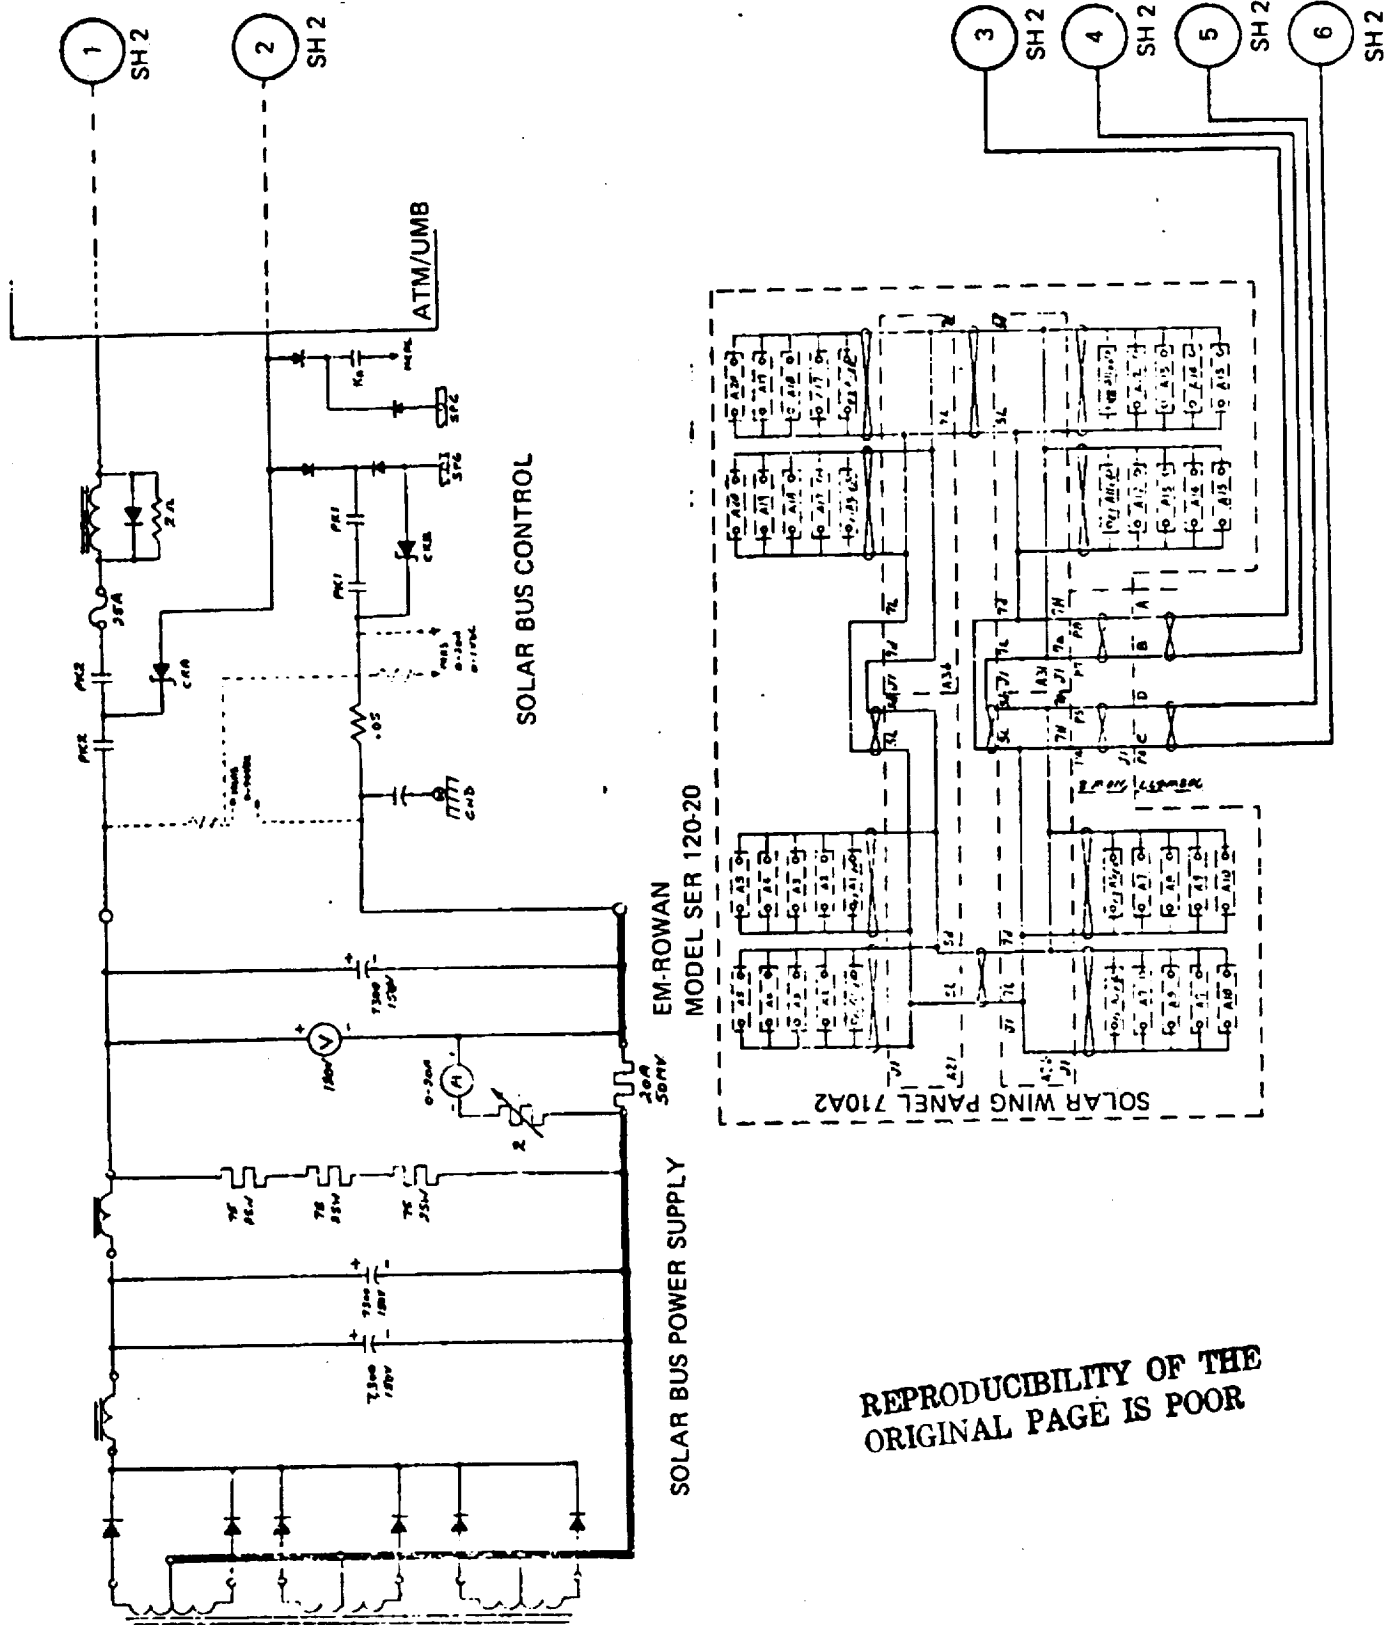
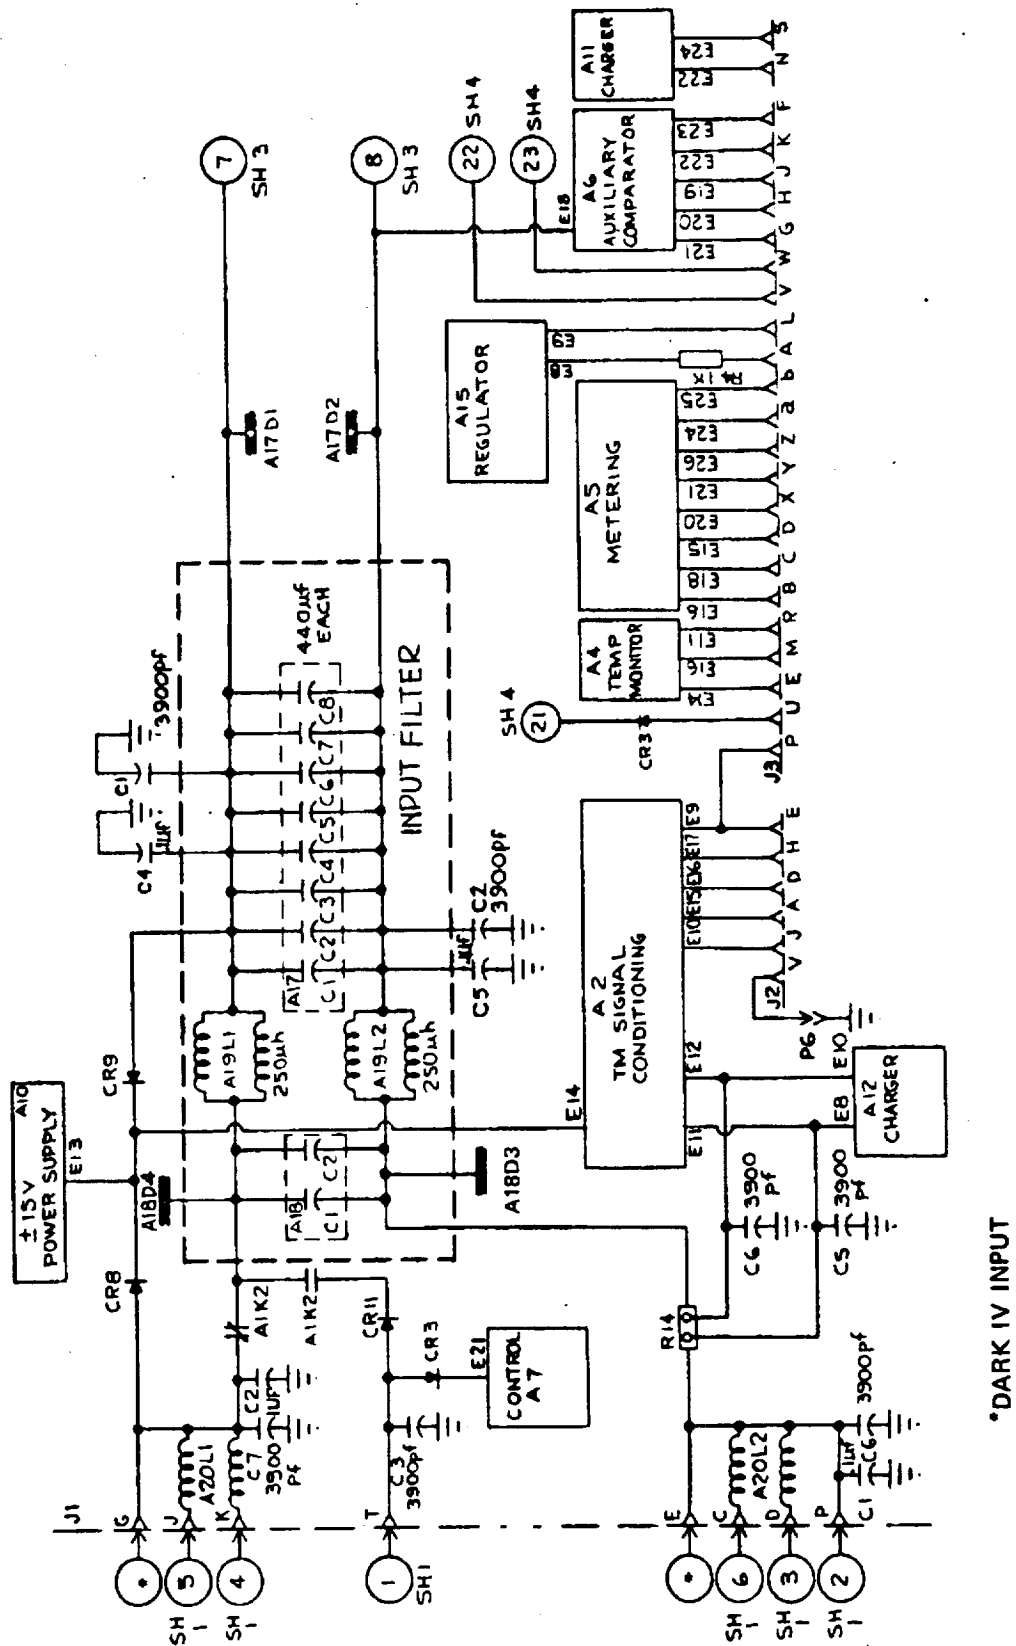
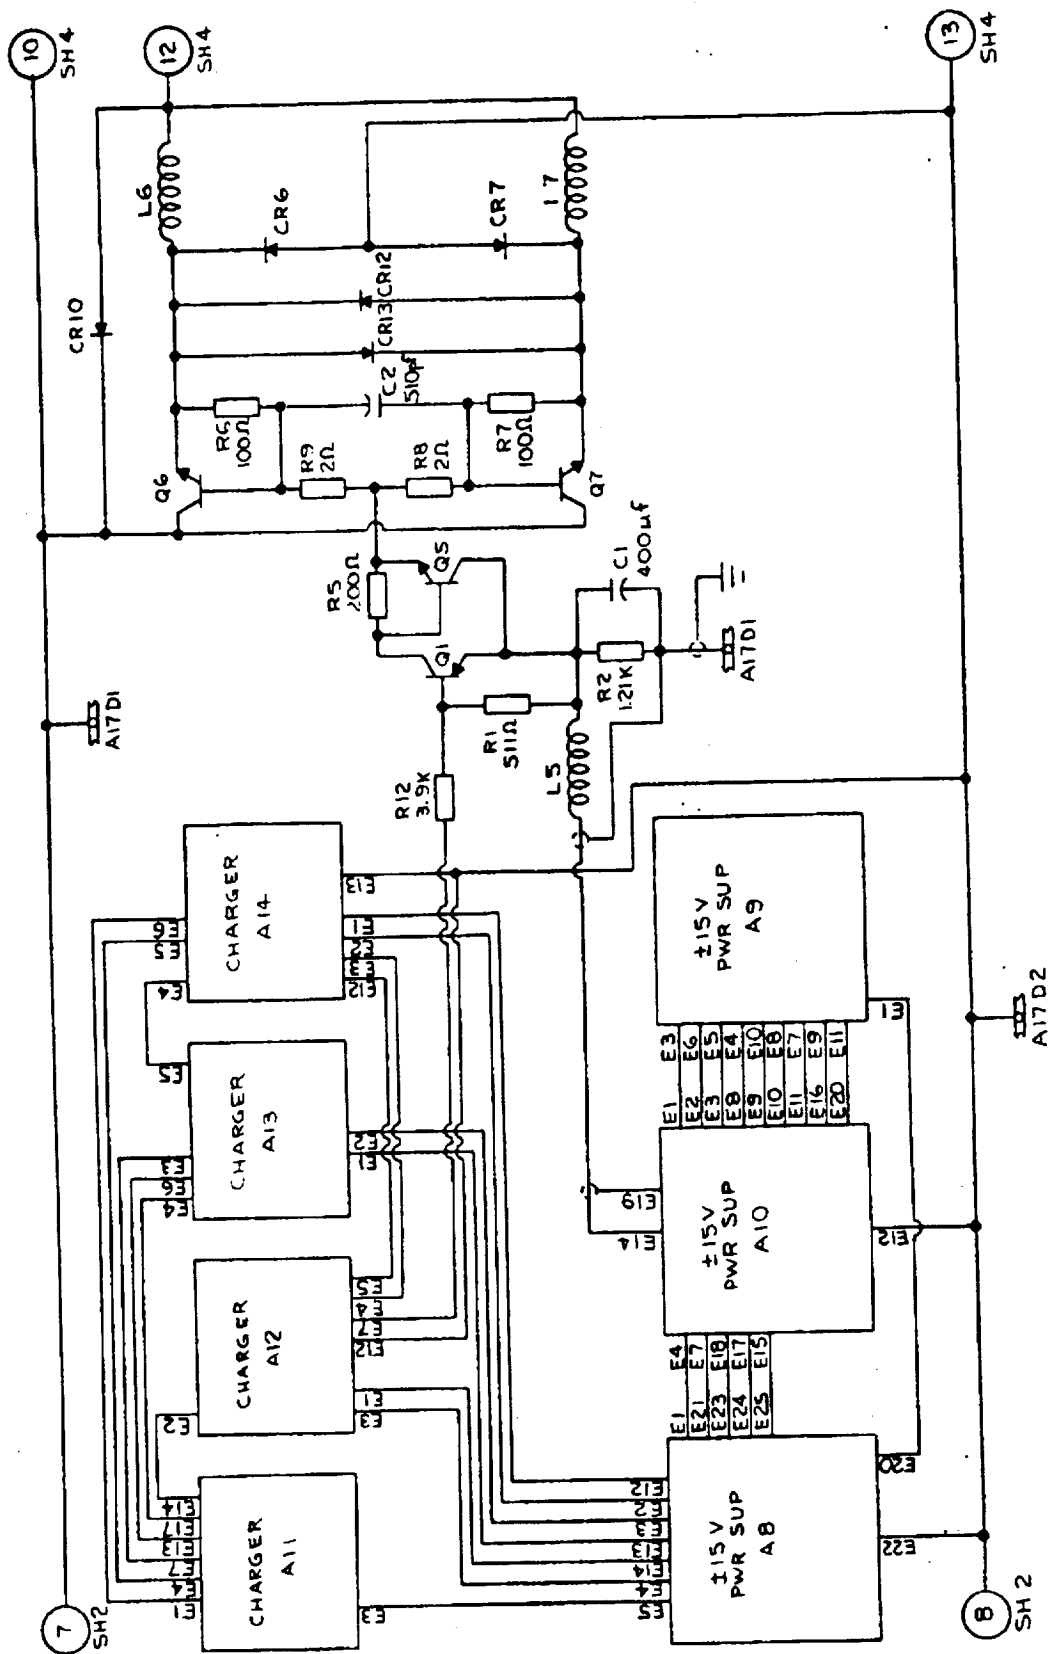
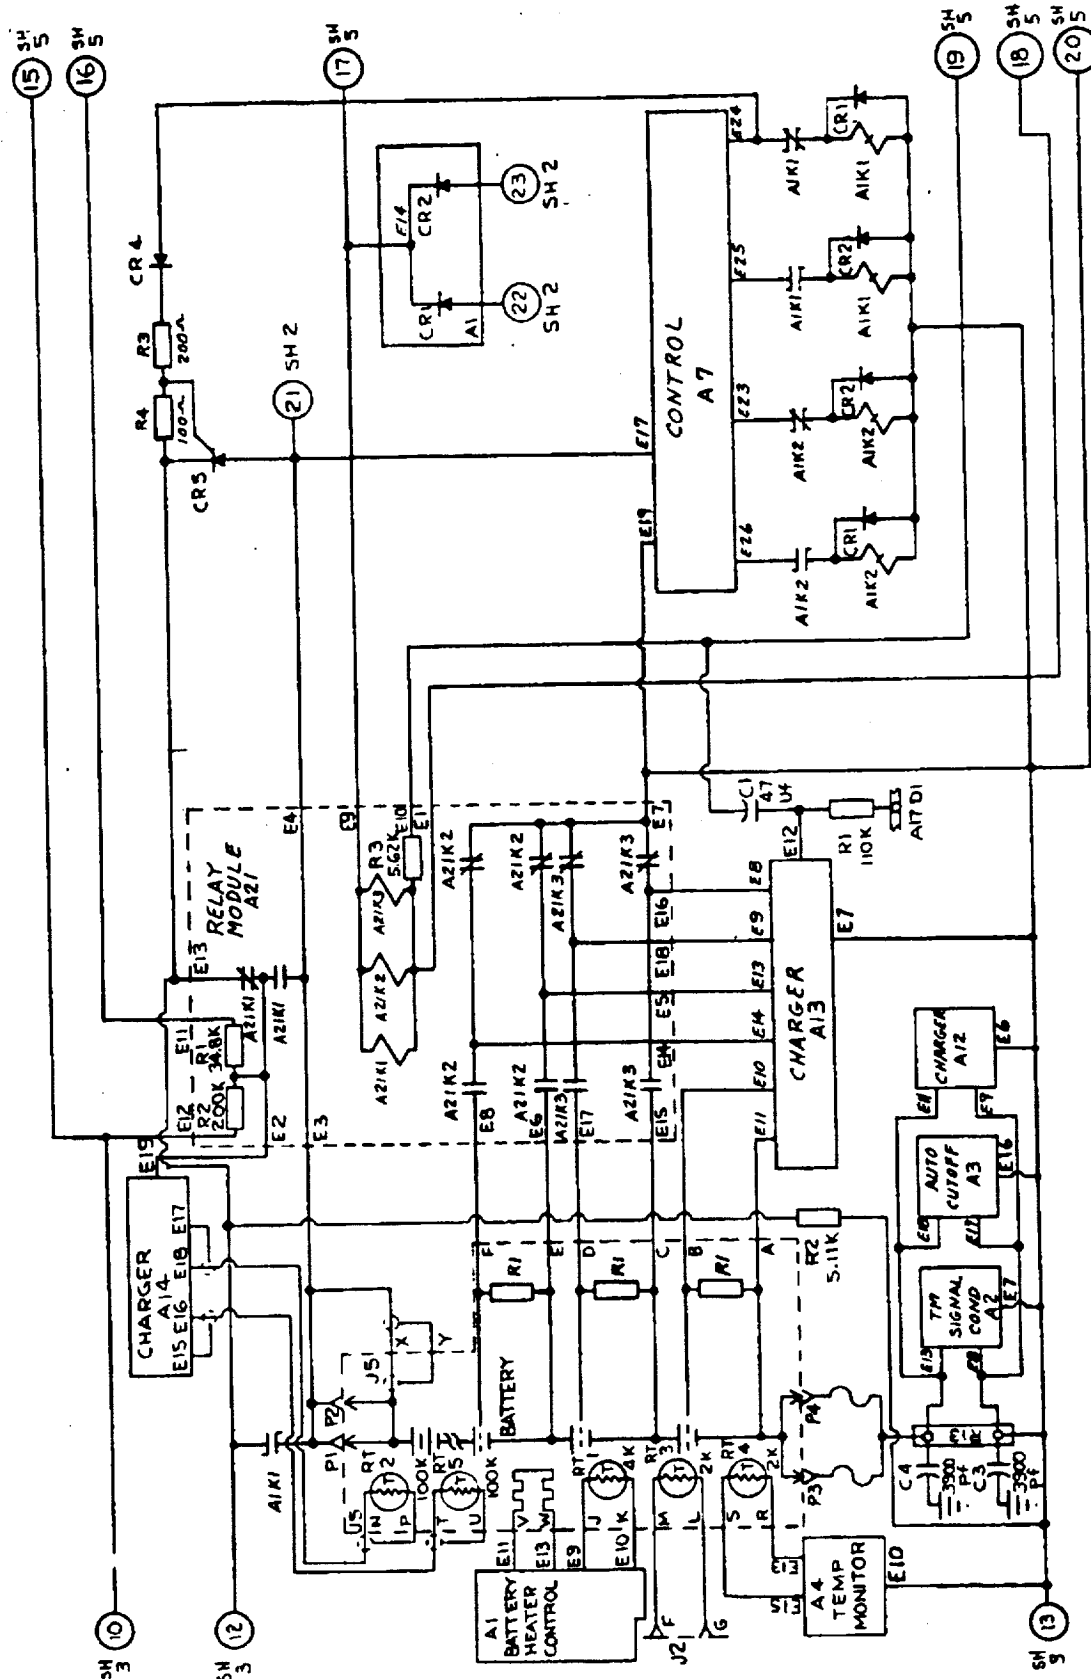
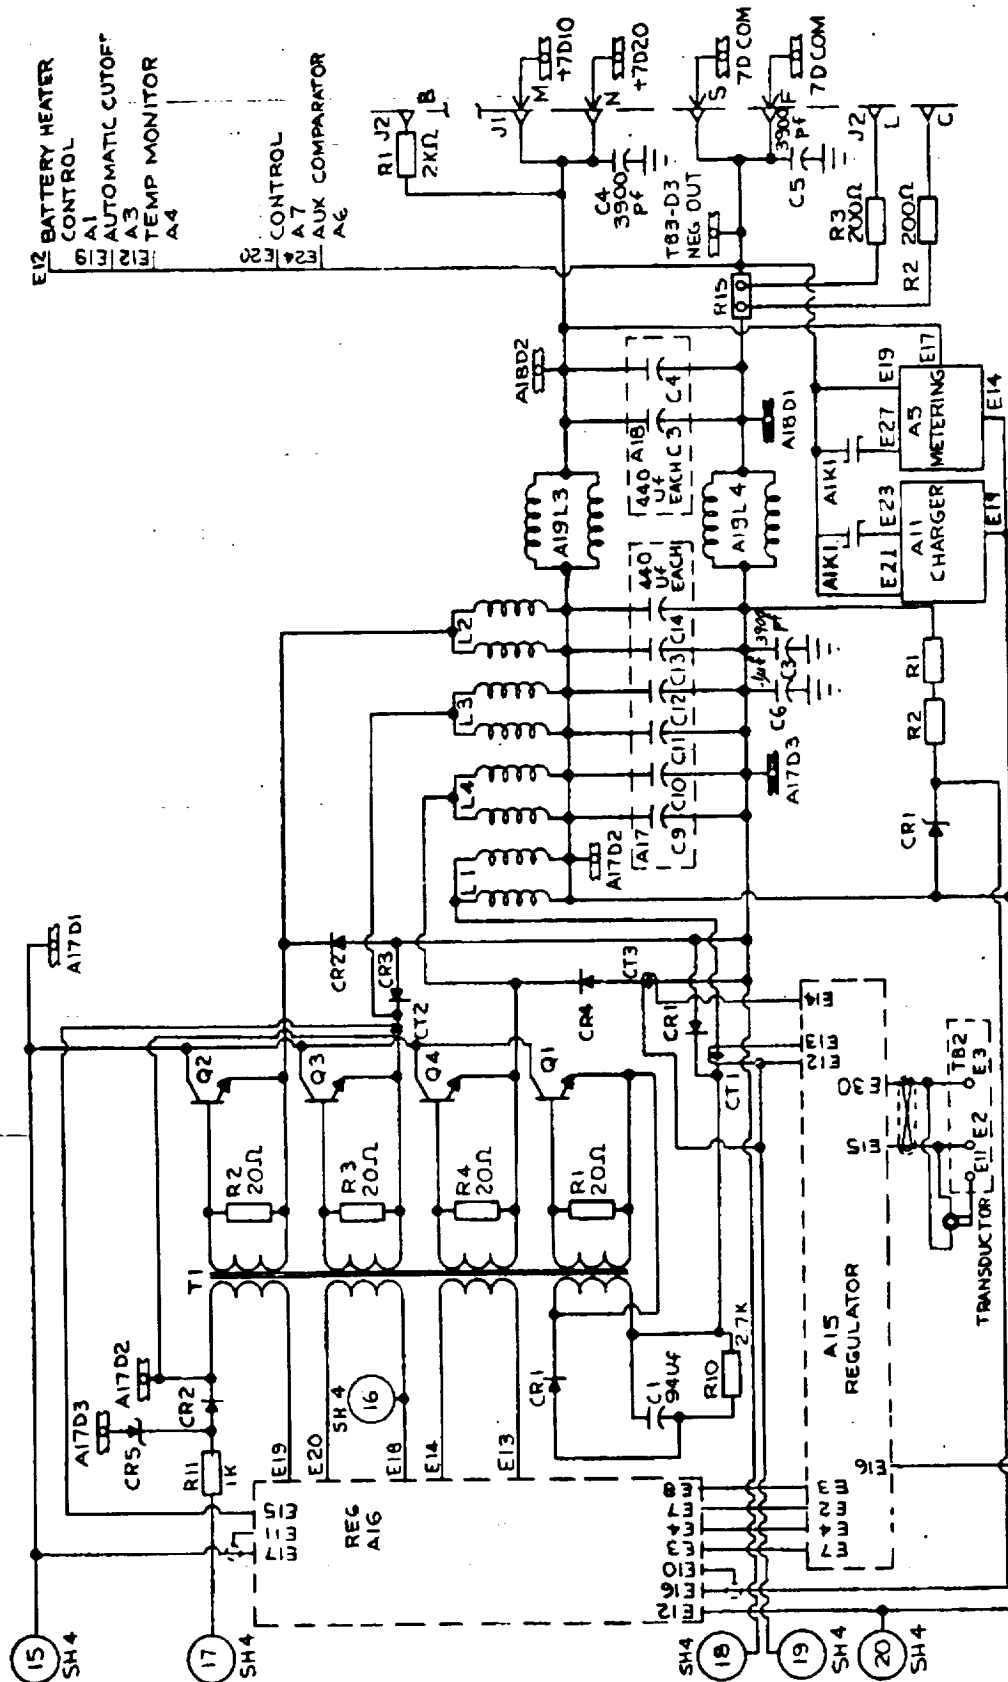
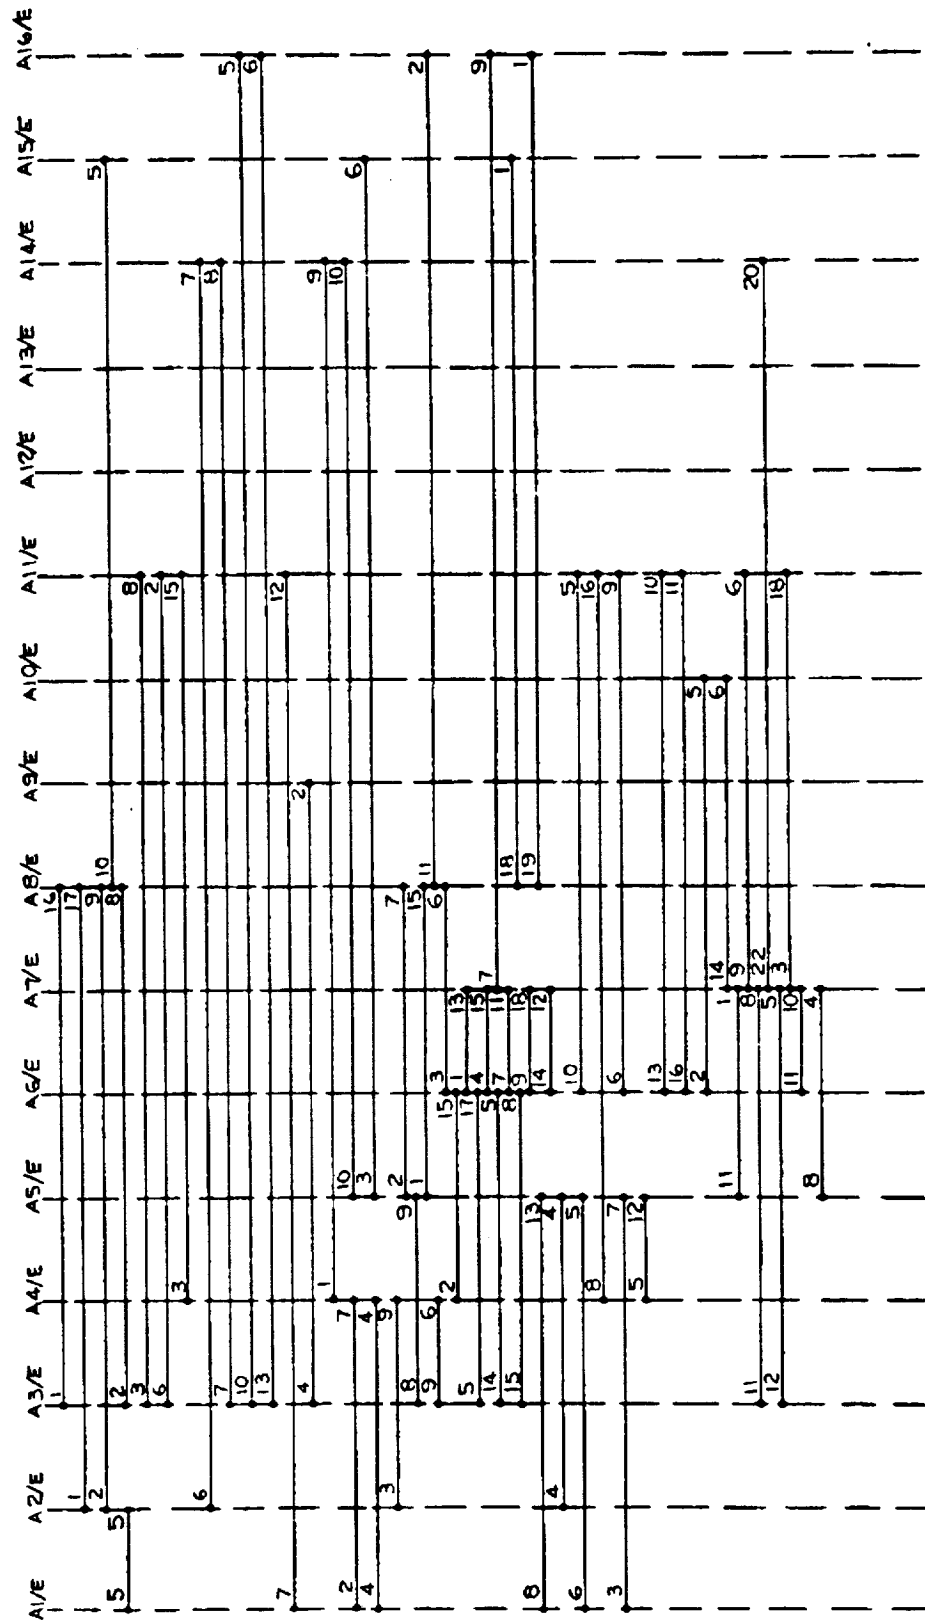
Figure 6.3.3-1. Simplified CBRM/ESE Schematic. (Sheet 1 of 6)

Sneak circuit analysis was performed on the CBRM/ESE circuitry to determine if a sneak path existed whereby reverse bias could be applied to wet slug tantalum capacitors in the CBRM. Such a path was found to exist in the trickle charge circuit. When the trickle charger is turned on/off, reverse bias can be applied to the input filter capacitors due to resonant ringing of input filter components. (See Figure 6.3.3-2.) Subsequent tests verified that reverse bias transients can occur when switching the trickle charger on and off.

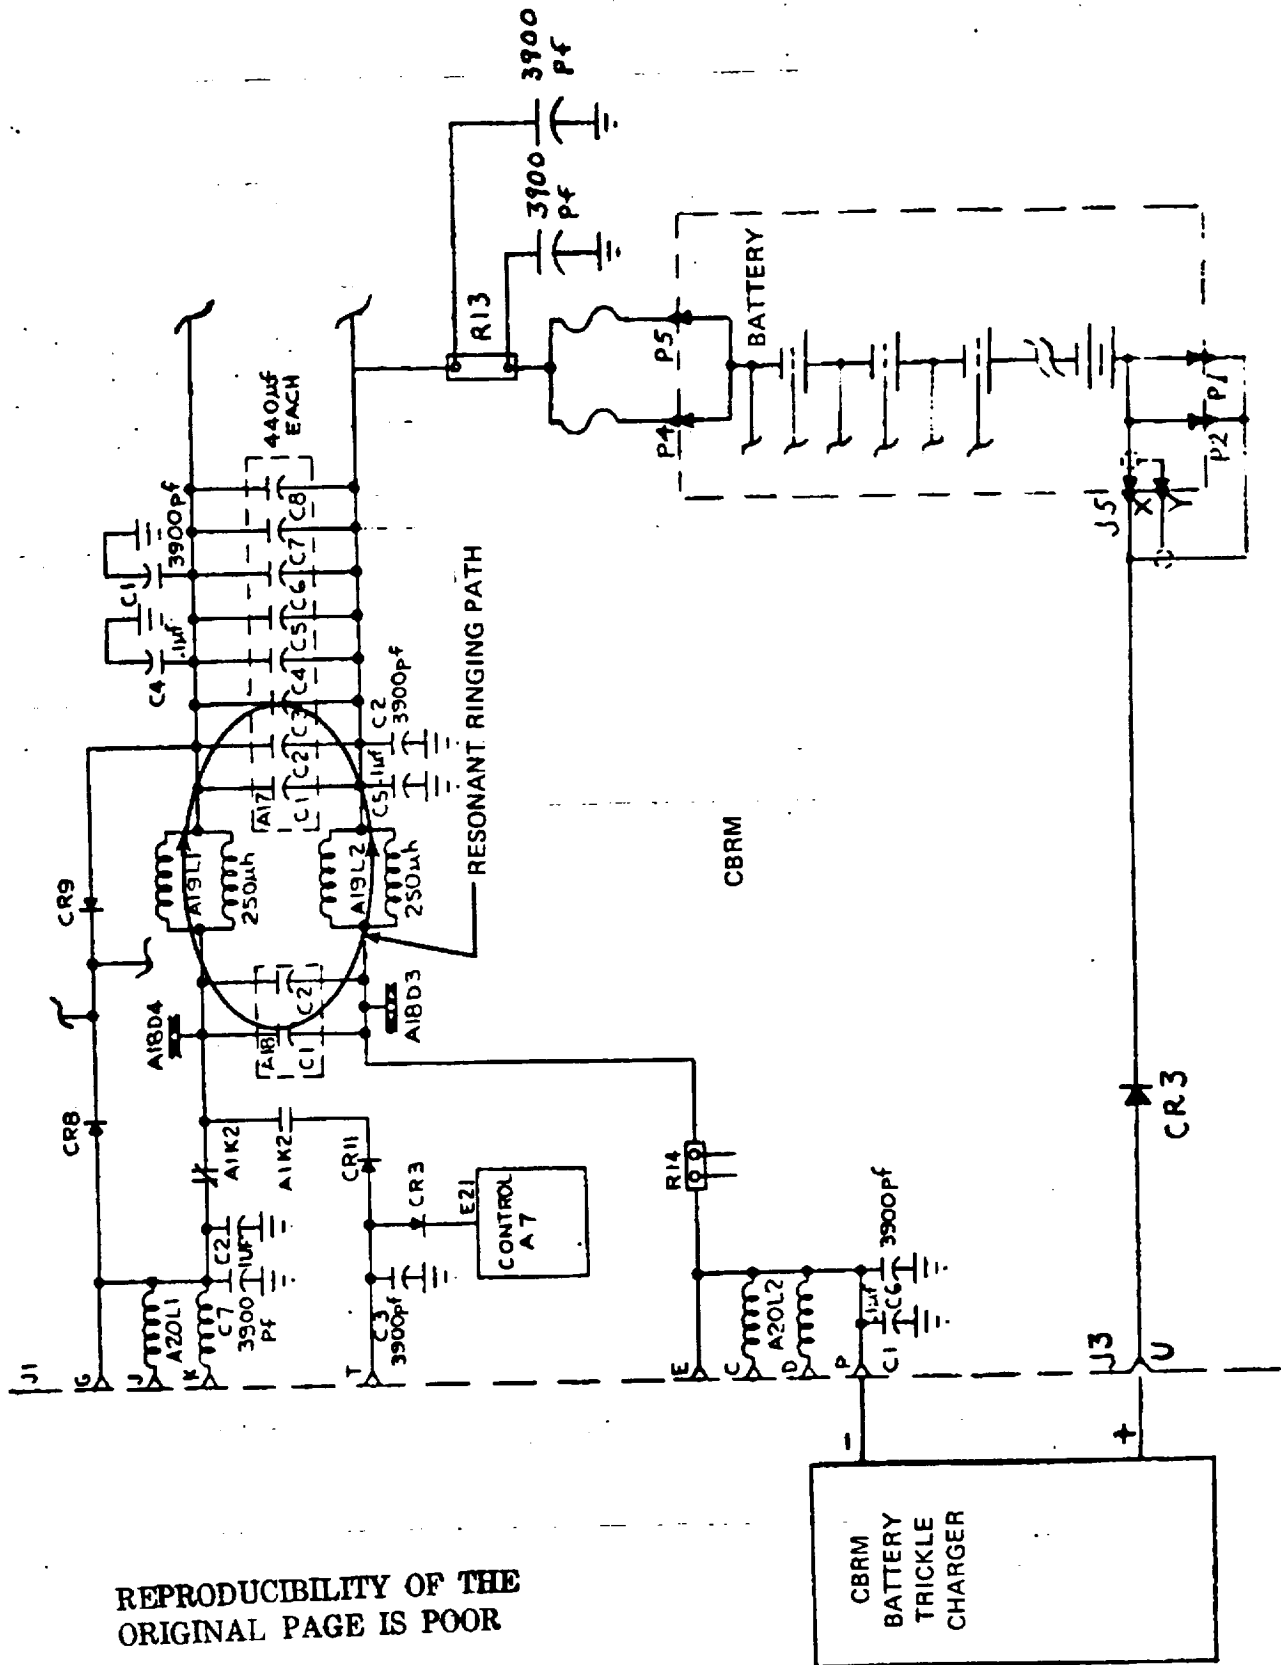
Figure 6.3.3-2. Schematic of CBRM Trickle Charger Circuit.

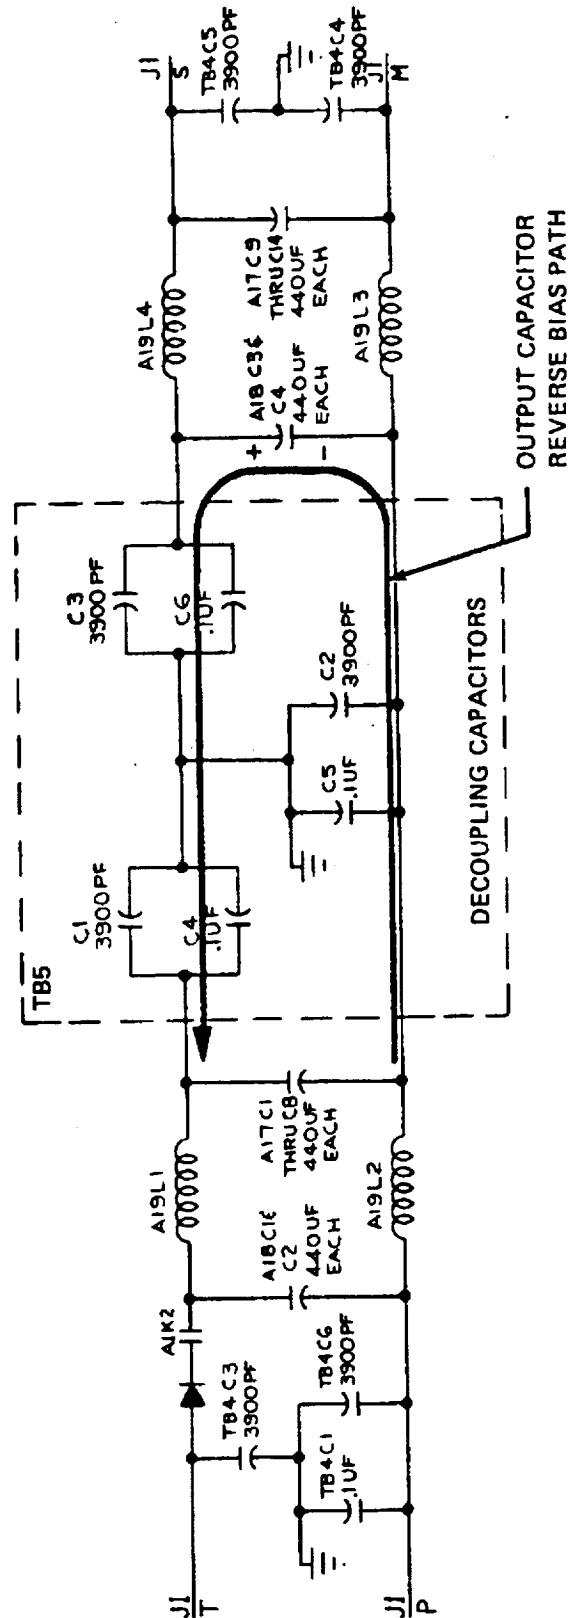
Figure 6.3.3-3. Schematic of CBRM Input and Output Filters Showing Decoupling Capacitors.

Decoupling capacitors were suspected as providing a sneak path for reverse bias. Sneak circuit analysis revealed such a sneak path (see Figure 6.3.3-3). However, laboratory measurements proved that the reverse bias thus generated was too small to cancel or reverse the normal static forward voltage present on the wet slug tantalum capacitors.

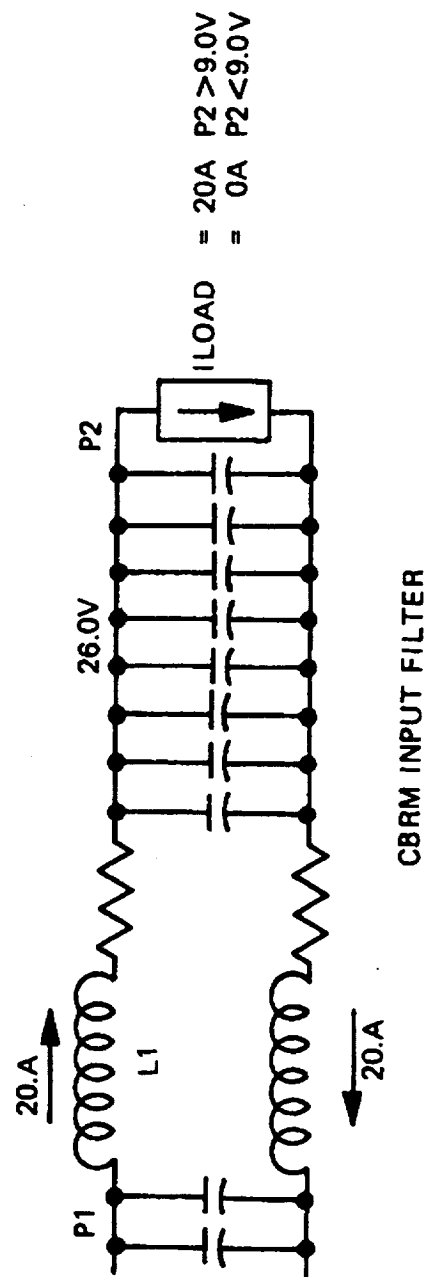
Figure 6.4-1. Equivalent Circuit for Electrical Conditions Immediately Following ESE Turn-Off.

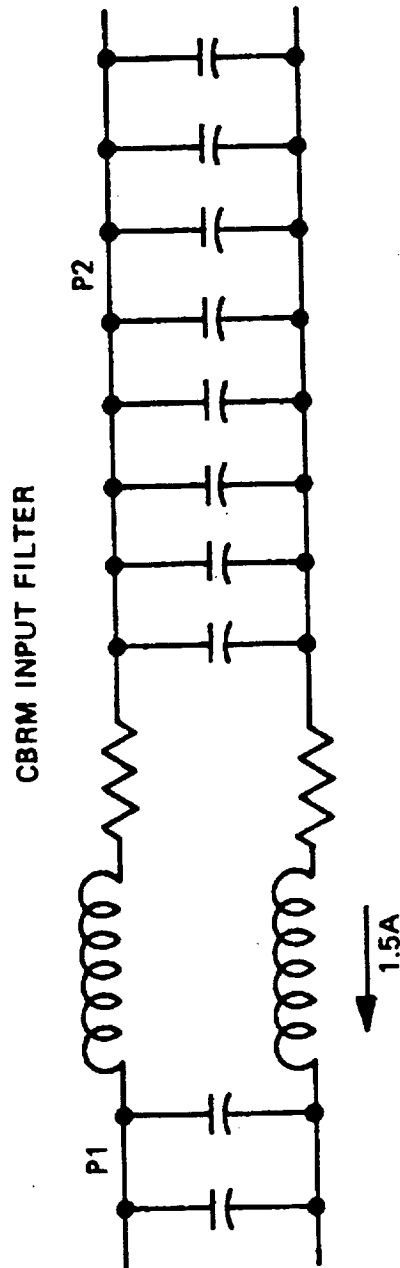
Figure 6.4-12. Equivalent Circuit for Electrical Conditions During Trickle Charger Turn-Off.

The equivalent circuit for the electrical conditions during battery trickle charger turn-off is shown in Figure 6.4-12. An initial condition of 1.5 amperes was assumed through inductor L2. Again reverse bias conditions were predicted across both the input and output capacitors in the input filter during the transient. The input capacitors saw a maximum of 0.93 volts reverse bias, and the output capacitors experienced a 0.19 volt reverse bias. The transient waveforms are shown in Figures 6.4-13 through 6.4-15.
